# FINAL REPORT for TESTS ABLE and BAKER

BUREAU OF AERONAUTICS  
GROUP

DIRECTOR OF SHIP MATERIAL  
JOINT TASK FORCE ONE

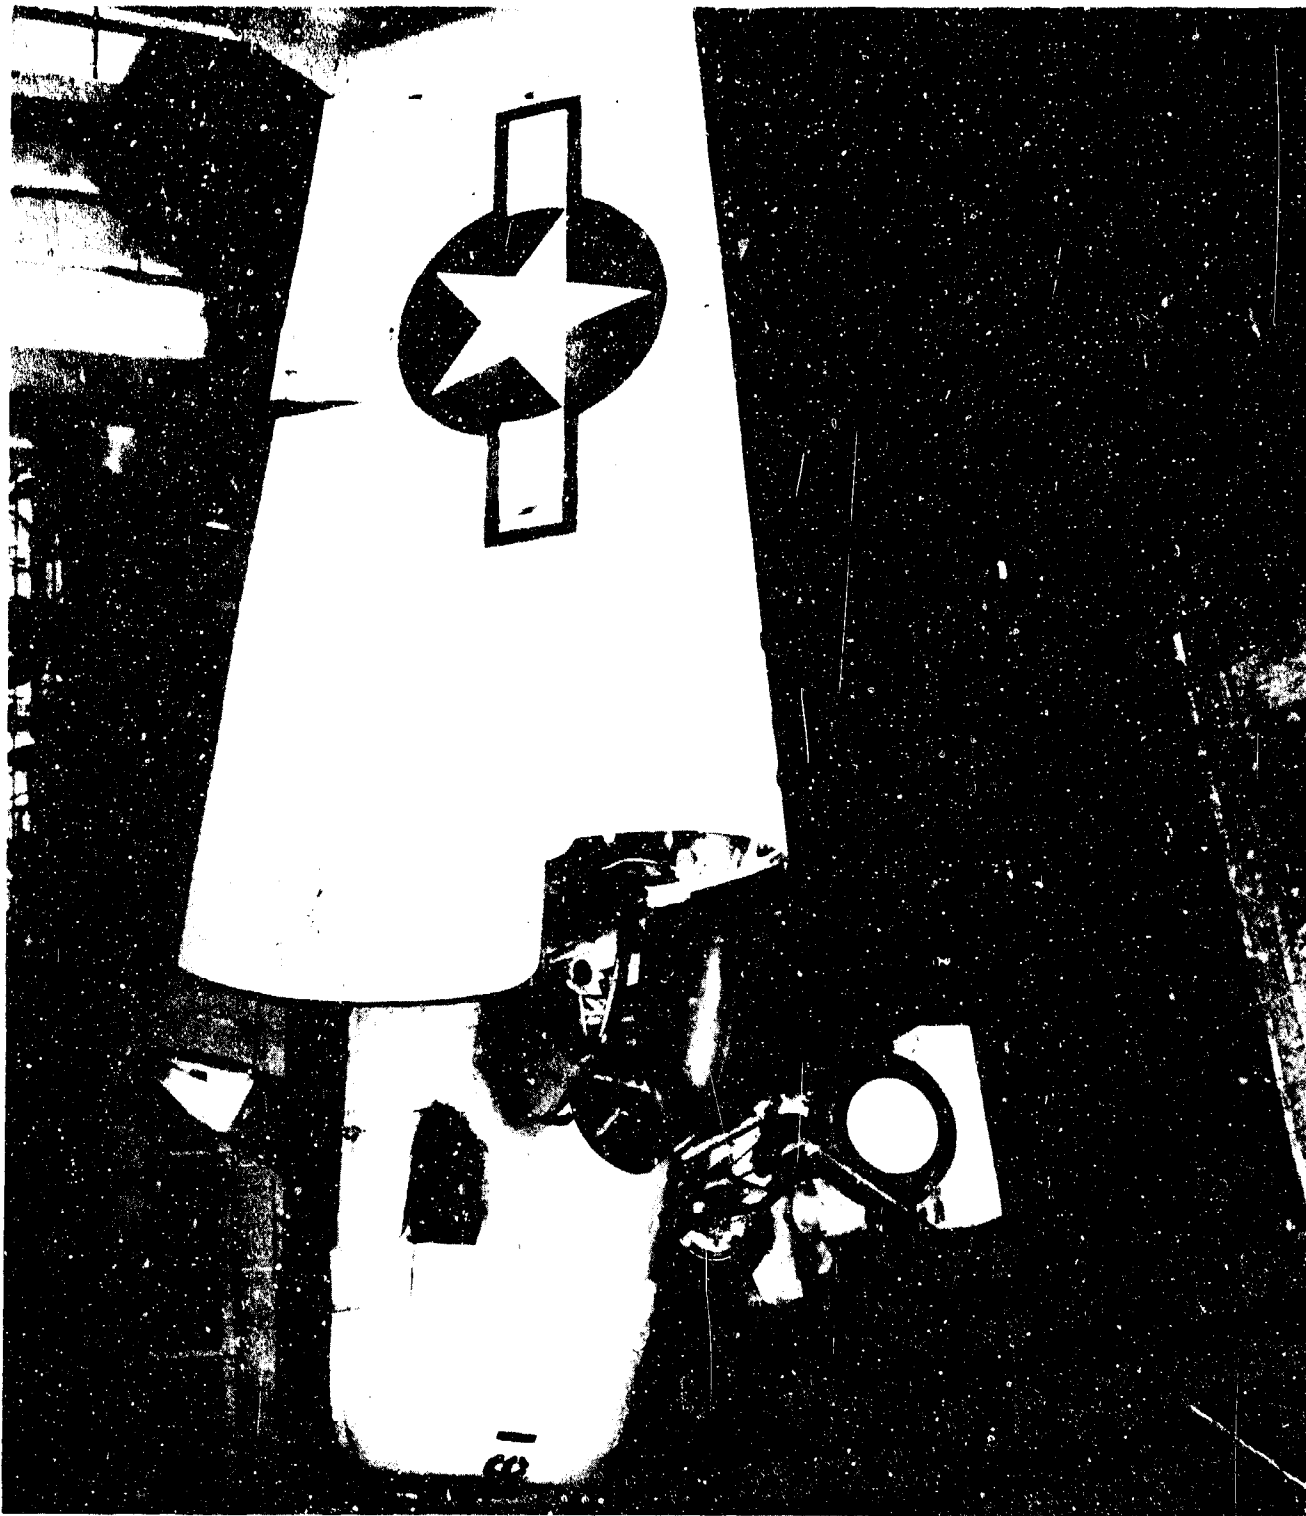
Model FM-2 airplane in cargo hold of USS BARROW APA-61 prior to Test ABLE. Typical securing methods used for aircraft on hangar deck and in holds.
